Re: Final Trip Report for the Odessa Biodiesel Site
Contract Number EP-S7-13-07, Technical Direction Document Number 15-03-0004

FINAL TRIP REPORT

Odessa Biodiesel Site
Odessa, Washington
TDD: 15-03-0004

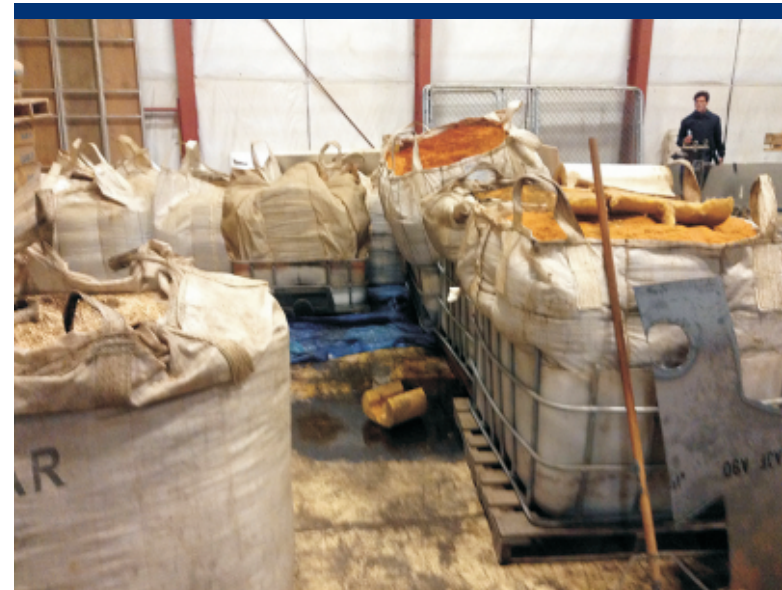
Photo 4 Totes containing contaminated ion exchange beads.

According to the final inventory, an estimated 68,500 gallons of chemicals, hazardous materials, and wastes were discovered on site and properly disposed of or recycled off site. In addition, there were numerous totes and tanks that contained flammable solids (ion exchange resin contaminated with sodium

methoxide). The estimated volume of these solids is 4,500 gallons. There were also several instances of spills and chemicals stored without regard to chemical compatibility.
